**DEPARTMENT OF TRANSPORTATION**

Contract #: 04-0120F4Cty: SF/ALA Rte: 80 PM: 13.2/13.9File #: 69.28**WELDING INSPECTION REPORT****Resident Engineer:** Pursell, Gary**Address:** 333 Burma Road**City:** Oakland, CA 94607**Report No:** WIR-001992**Date Inspected:** 19-Apr-2008**Project Name:** SAS Superstructure**OSM Arrival Time:** 1400**Prime Contractor:** American Bridge/Fluor Enterprises, a JV**OSM Departure Time:** 300**Contractor:** Zhenhua Port Machinery Company, Ltd (ZPMC), Changxing Island **Location:** Shanghai, China

**Bridge No:** 34-0006**Component:** Tower skin plates**Summary of Items Observed:**

## WELDING INSPECTION REPORT

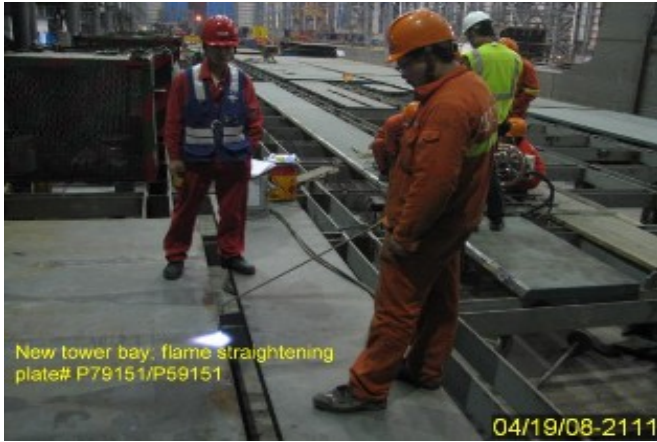
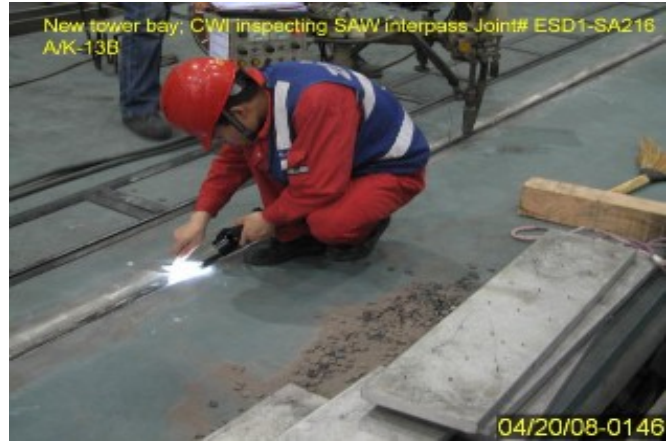
QA observed ZPMC qualified welding personnel perform the last three SAW passes on one side of the groove weld joining tower skin plates, weld# SSD1\_SA16E1G-10A following the guide lines of approved WPS# WPS-B-T-2221-B-U3c-S. QA observed 2 ZPMC Quality Control (QC) inspectors in the vicinity of the welding operations including ZPMC CWI identified as An Qingxiang. There was also 1 American Bridge/Fluor (ABF) QC inspector in the area as well. ZPMC and ABF Quality Control (QC) inspectors performed a full visual inspection of the completed SAW weld and it appeared to be in compliance with AWS D1.5 2002 and the contract documents.

QA observed ZPMC qualified welding personnel perform the SAW groove weld joining tower skin plates, component# P793 (E)-1 SA216 (E) joint# ESD1-SA216 A/K-13B. QA observed 2 ZPMC QC inspectors in the vicinity of the welding operations including ZPMC CWI identified as An Qingxiang. There was also 1 American Bridge/Fluor (ABF) inspector in the area as well. ZPMC and ABF Quality Control (QC) inspectors performed a full visual inspection of the SAW root weld on the above mentioned weld and it appeared to be visually non-compliant with AWS D1.5 2002 and the contract documents due to four areas of what appeared to be slag inclusions on or near the surface of the weld. ZPMC CWI identified as An Qingxiang and ABF QC inspector identified as Li Hanjie instructed ZPMC qualified welding personnel to grind the areas to sound metal and repair by welding using the SMAW process following the guide lines of approved repair WPS# WPS-345-SMAW-1G-repair. The repaired areas measured approximately 150mm to 300mm in length. After the completion of the repairs the repaired areas were Visually Tested (VT) by both QA and QC and appeared to comply with AWS D1.5 2002 visual acceptance criteria and the contract documents. After the completion of the repairs and VT ZPMC qualified welding personnel proceeded with SAW welding of this joint. ZPMC utilized the following two WPS's to perform the welding on this joint: WPS-B-T-2221-B-U3c-S-1 for the root pass and WPS-B-T-2221-B-U3c-S for all subsequent weld passes. They ran six additional weld passes by the end of the shift. QC informed QA that ZPMC will turn this skin plate over, back gouge and continue SAW welding the other side of this plate tomorrow (4/20/08). As of this date SAW welding has not been completed on either side of this plate. The welder identification and the welding parameters as measured with Quality Controls calibrated instruments appeared to be in conformance with the posted WPS's and were as follows:
